SUBJECT: City Industries NPL Site
Five-Year Review

Superfund Five-Year Review Report

City Industries Superfund Site
Winter Park, Florida

Prepared for
U.S. Environmental Protection Agency, Region IV
August 1999

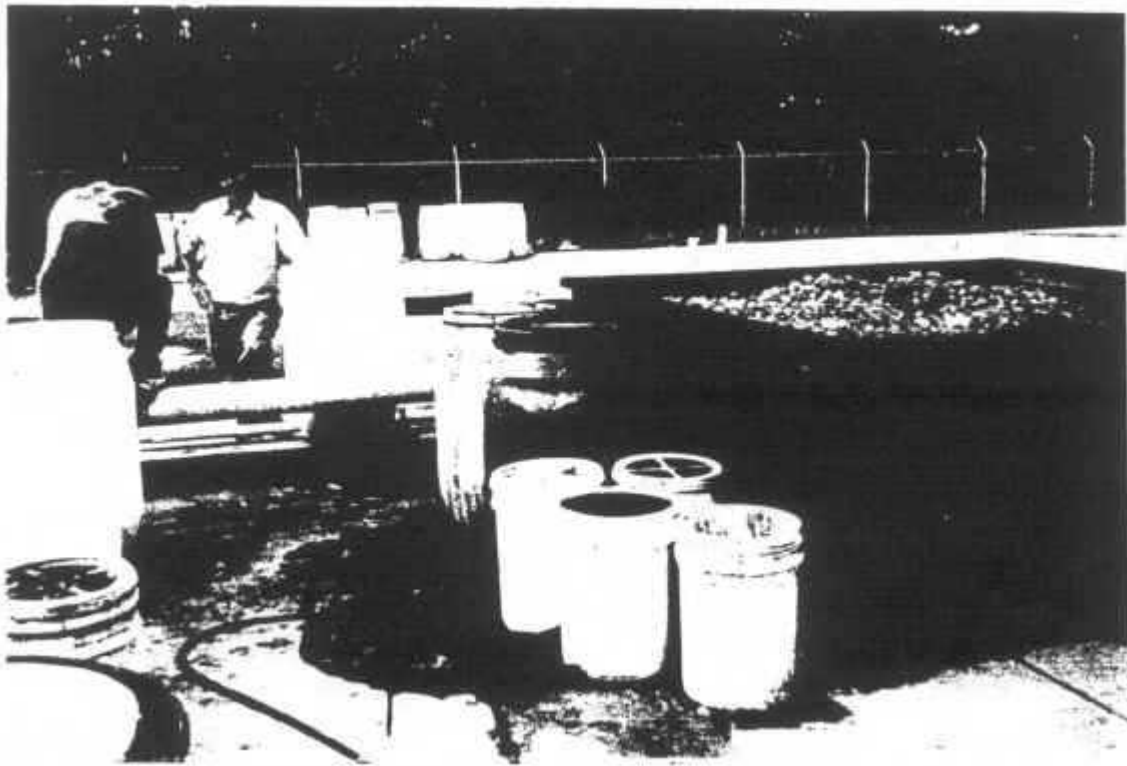
Photo 5 - View of Air Stripping Tower Media and Cleaning Area

Air Stripper The fiberglass air stripper unit (see photograph) is three (3) feet in diameter, 45 feet tall, and contains 142 cubic feet of Jaeger #3 packing. The air stripper packing is subject to biofouling and requires cleaning at six-month intervals using muratic acid. Biogrowth causes head loss through the stripper, and eventually sloughing into the effluent stream which has resulted in an exceedance in the

*Packing material (see photo) in air
stripper requires cleaning and change out on
6 month intervals due to high air bacteria
build up. Pumps also require cleaning - caused by
air bacteria fouling.*
